Manhole Inspection Summary

Manhole # S27S1_011MH

Insp Date: **5/5/08 10:51 AM**

Location Address: **801 Marmenco Ct.**

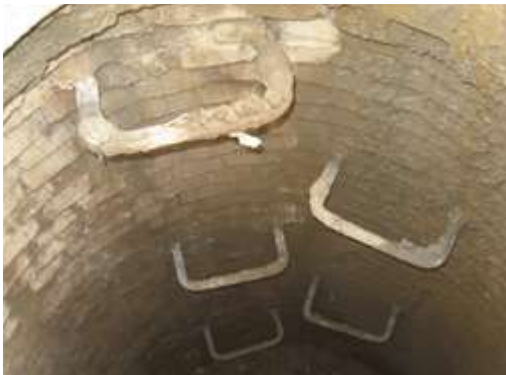
Steps

Count: **5** Missing: **0** ☒ **Corroded**

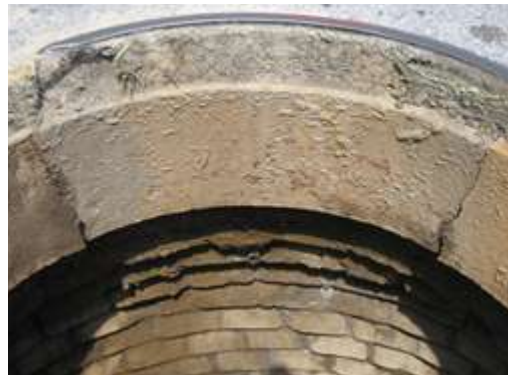
Defect 1

Condition: ☐ Sound ☒ **Cracked** ☐ Leaks

Frame cracked

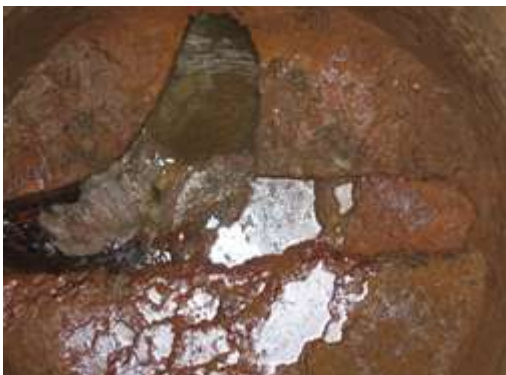
Defect 2

Condition: ☐ Sound ☐ Cracked ☐ Root Intrusion ☐ Deteriorated ☐ Leaks ☒ **Debris**

Channel blocked

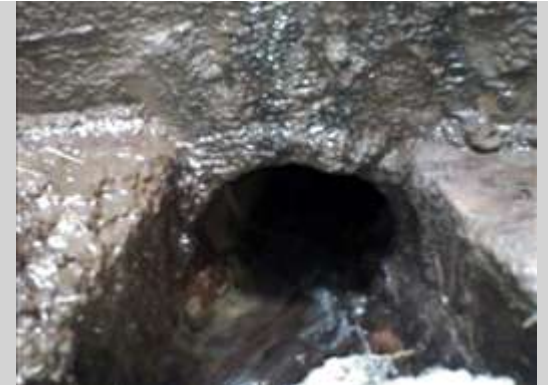
12 O'Clock Outflow

8 in. Circular Gravity Sewer
Pipe Out @ 12 O'Clock

Pipe Height: **8.4** (in.) Rod and Bar (Angled)
Pipe Material: **Clay** ☐ Pipe Lined
Invert Depth: **9.72** (ft.) Flow Characteristics: **Fast**
Deposits: ☒ None ☐ Mud ☐ Gravy ☐ Debris ☐ Grease
Silt Depth: (in.) Deposits Extent:
Infiltration: **None** Pipe Seal Cond: **Sound**

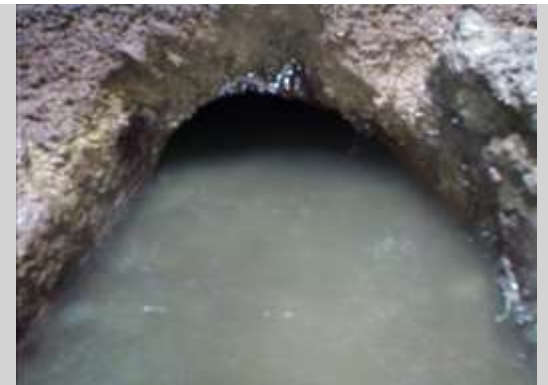
3 O'Clock Inflow

8 in. Circular Gravity Sewer
Pipe In @ 3 O'Clock

Pipe Height: **8.4** (in.) Rod and Bar (Angled)
Pipe Material: **Clay** ☐ Pipe Lined
Invert Depth: **9.46** (ft.) Flow Characteristics: **Slow**
Deposits: ☒ None ☐ Mud ☐ Gravy ☐ Debris ☐ Grease
Silt Depth: (in.) Deposits Extent:
Infiltration: **None** Pipe Seal Cond: **Sound**

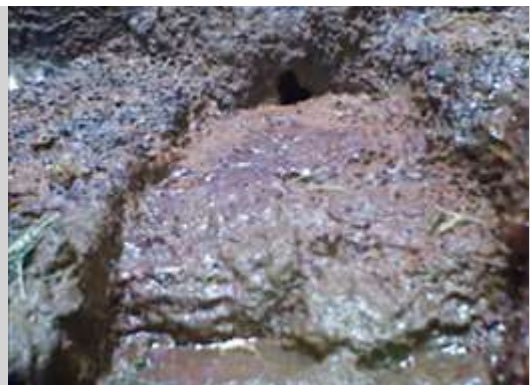
6 O'Clock Inflow

Pipe In @ 6 O'Clock

Deposits: ☐ None ☒ **Mud** ☒ **Sludge** ☐ Debris ☐ Grease

Silt Depth: **6** (in.) Deposits Extent: **Heavy**
